Smoke and Dye-Water Observation Summary

Western Run Pilot Project - Baltimore Maryland

INSPECTION REPORT

STREET: PARKS HEIGHTS AVE. 94 B 1	MAP #1: 1	MH: 1521101
CITY: BALTIMORE	MAP #2:	MH: 1521102
LOCALE: MAIN RESIDENTIAL STREET	TAPE #: JAM 2	TV'D LGTH: 36.22 ft

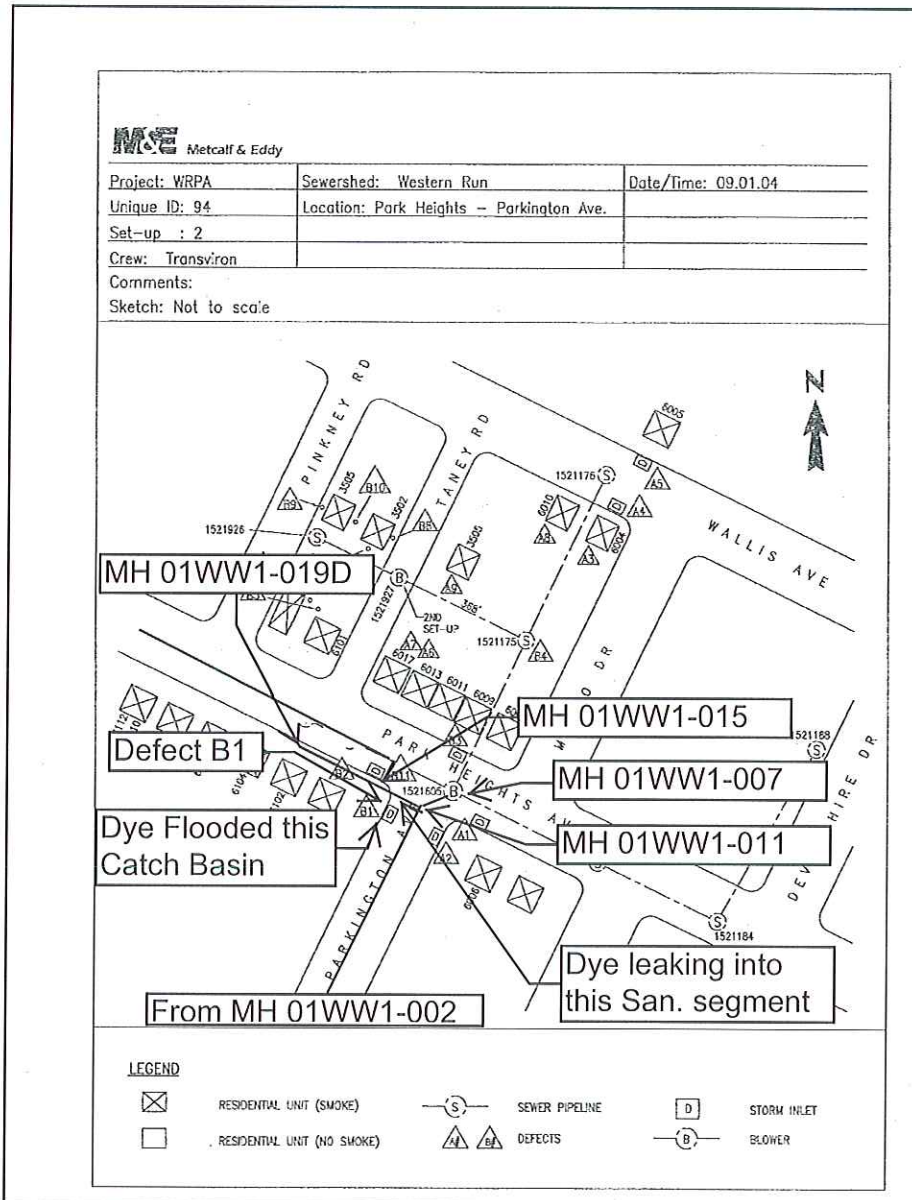
Sketch No: 94

RESULT CODES		SOURCE TYPE CODES		
1. POSITIVE	1. MAIN SEWER	5. DOWN SPOUT	9. STAIRWELL DRAI	13. STORM DRAIN
2. NEGATIVE	2. SERVICE LINE	6. DWNSPT CONN.	10. FOUNDATION DRAIN	14. CATCH BASIN
3. CANNOT TEST	3. TRANSITION JOIN	7. AREA DRAIN	11. BUILDING INTERIOR	15. STORM MH
	4. CLEAN OUT	8. DRIVEWAY DRAIN	12. MH FRAME/SEAL	16. STORM DITCH
Additional Comments: DYE LEAKING INTO LINE BETWEEN				
1521101 & 1521102				
PHOTO DID NOT MATCH SKETCH
